Doct. of Philosoph. Science, Cand. of Techn. Sciences Popov S. N.

Cand. of Techn. Sciences, Ass. Prof. Shumykin S. O.

National University «Zaporizhzhia Polytechnic», Zaporizhzhia

STUDY OF THE FEATURES OF THE WEAR OF A FRICTION PAIR OF A DRIVE WHEEL WITH A MOVER CATERPILLAR UNDER ABRASIVE CONDITIONS

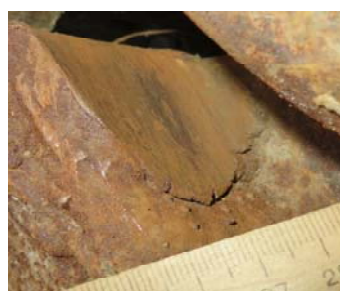
Fig. 2. The nature of the destruction of the working surface of the drive wheel

The study of the working surface of the teeth of the drive wheel (Fig. 2) showed the presence of grooves, scratches and holes, which indicates a complex mechanism of destruction of the friction surface, which consists of the interaction of metal - metal, and metal - abrasive particle. At the same time, the mechanism of abrasive wear is fixed under conditions of both fixed and semi-fixed contacting of the tribosystem, which causes an increase in the wear rate of the part.

The destruction of the friction surface of this kind is a consequence of the fact that in the conditions of industrial and construction areas where there are no hard coatings, as well as in the conditions of impassability, plowing, and loose soils, the abrasive particles get into the engagement between the friction pair of the wheel – caterpillar. Analysis of the wear surface registers the presence of damage associated with the contact of the metal with abrasive particles. On the surface (Fig. 3), tracks from the passage of the abrasive are visible, as evidenced by the presence of grooves and scratches.

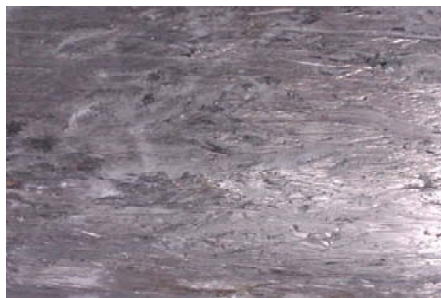
Fig. 3. The friction surface after wear with the presence of grooves, scratches and holes

In addition, traces of the irregular shape of ovals are clearly visible, which is typical for the formation of deep holes (150–650 microns), which arise as a result of local shock loading. This picture indicates the possibility of jamming and the likely process of crushing of abrasive particles in the gap between the mating surfaces. Consideration of the latter can be classified as elements of impact-abrasive wear in the conditions of a fixed and semi-
